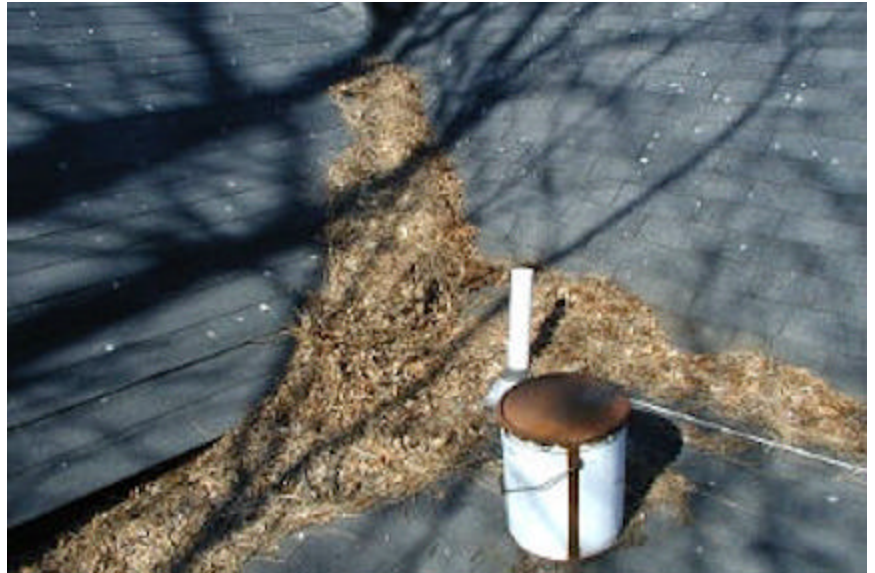
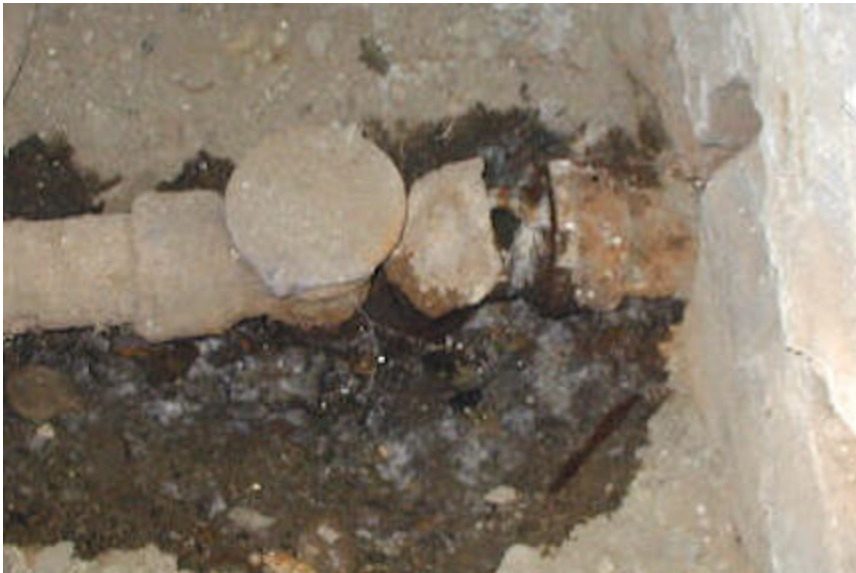
Rear valley appeared prone to ice dam water leakage (that was an old bucket of roof tar / sealant material.)

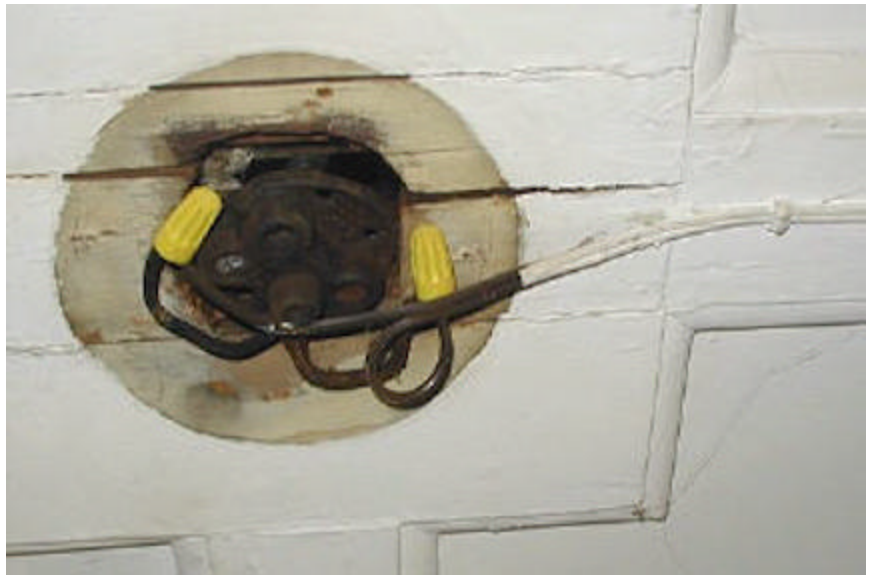
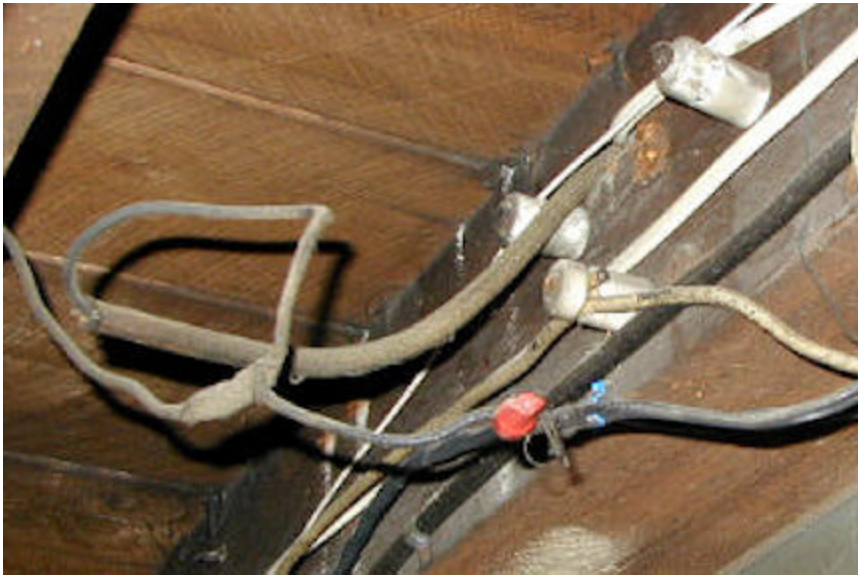
Extension cord found to be in use as permanent wiring.

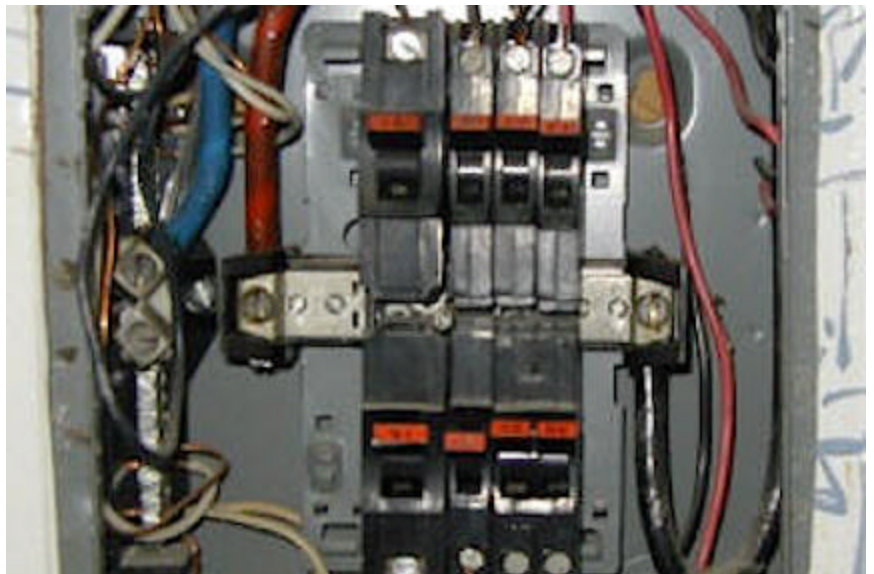
Old knob and tube wiring was observed to be still in use.

Federal Electric Panel.
