Home / Building Inspection Report

Report prepared for: John Doe

Property address: 123 Main St, Somewhere, MA, 012345

Property type: Two family, Victorian colonial.

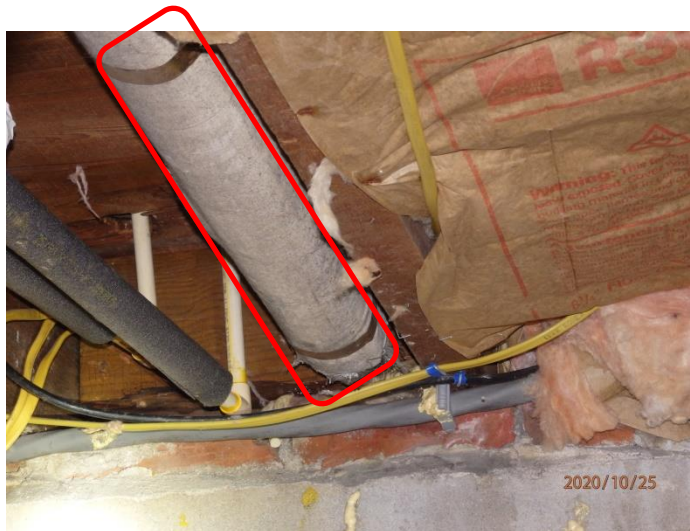
Suspected asbestos containing material was observed wrapped around an old (abandoned) heating pipe in the crawlspace. (The finished basement may be covering / concealing other abandoned pipes that could have the same insulation on them.) Identification of asbestos requires laboratory analysis that is outside the scope of a Home Inspection. If the material is damaged the fibers can be released and can mix with the dust and remain in the basement area for an indefinite period of time. In most cases the type of material observed on heating pipes such as these is identified as containing asbestos. <http://ablehomeinspection.com/asbestos.html>

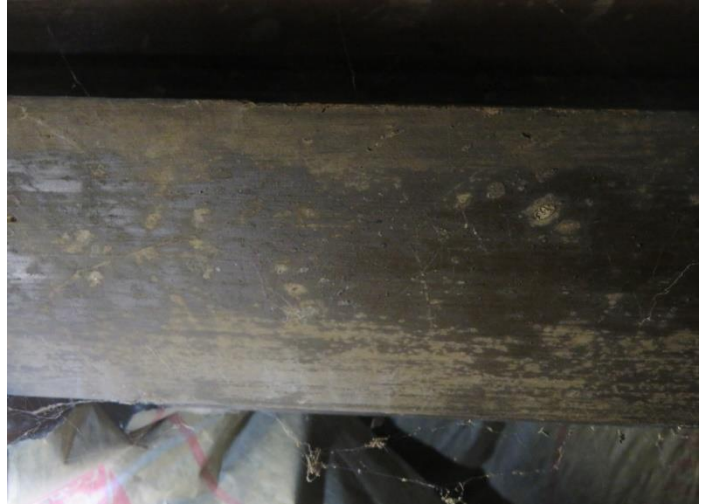
Rodent droppings were observed in the small basement crawl space. A professional pest control operator should be contracted. Rodent poison was also found.

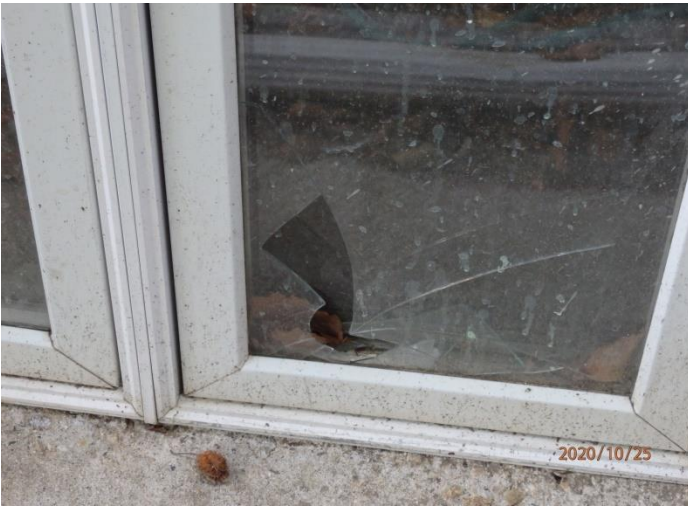
Basement Windows: ----- Appeared functional except; Old / worn. Broken glass pane found.

Broken glass pane at left side basement window

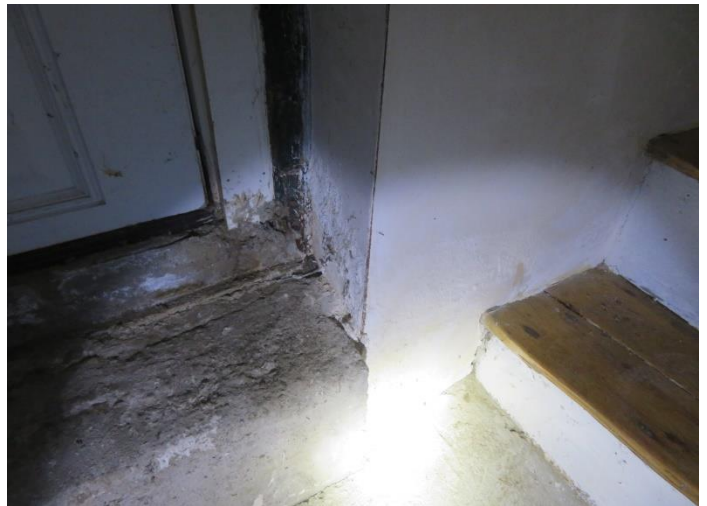
Exterior Basement Door: ---- Appeared functional except; Evidence of water seepage at the bottom of door noted.

Evidence of minor water seepage found at rear basement door

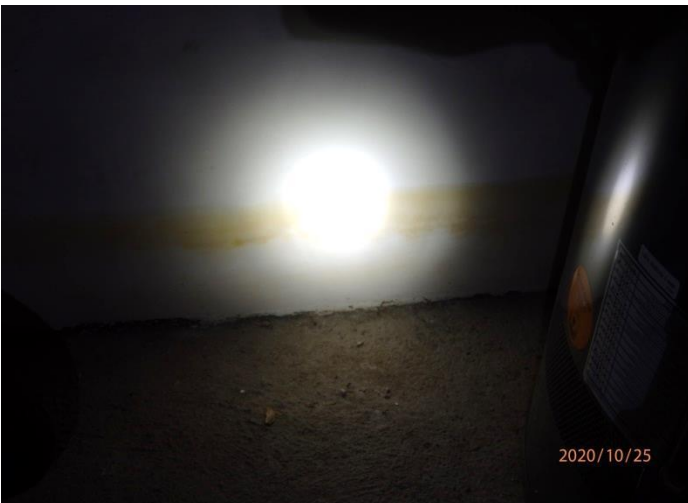
Water In Basement?¹ ----- No major evidence found except; Water stains were observed at the bottom of a finished wall in a basement utility room (next to garage.)

Water stain found on basement utility room wall next to garage.

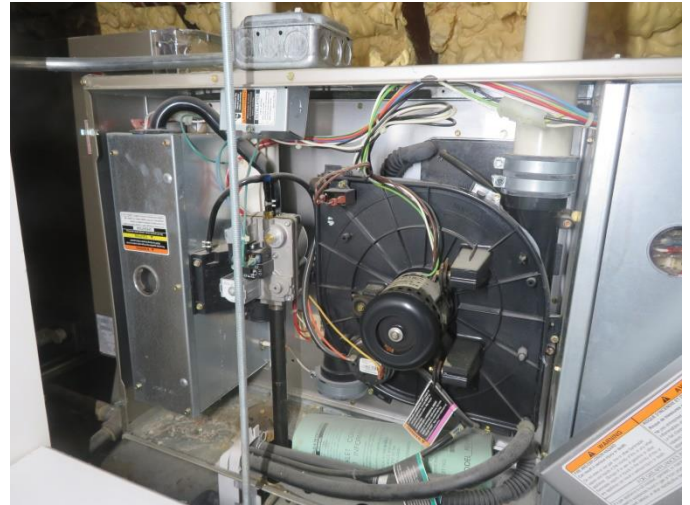
Condensation leakage evidence was found behind the attic furnace cover. Small puddles of water were visible. This indicates that that condensation line may be leaking. Repair needed.

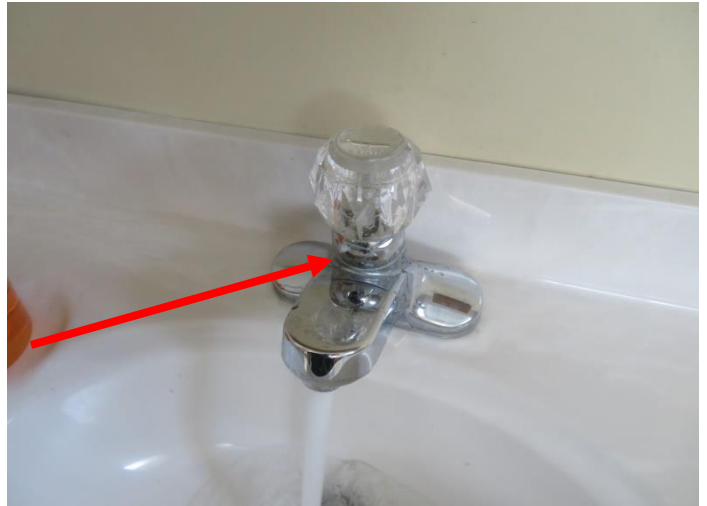
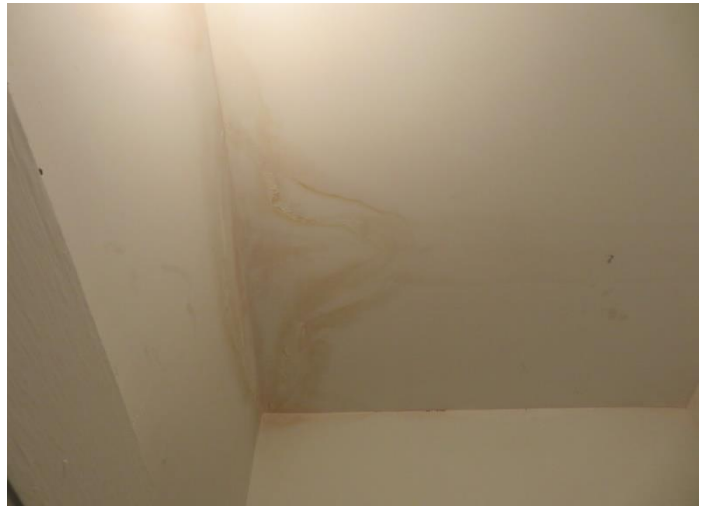
The bath sink faucet leaked through the valve stem when opened, repair / replacement needed.

Investigate Further - Water stains were observed at a 2nd floor bedroom closet ceiling under a 3rd floor bathroom. Recommend having the owners ensure all leakage issues have been repaired.

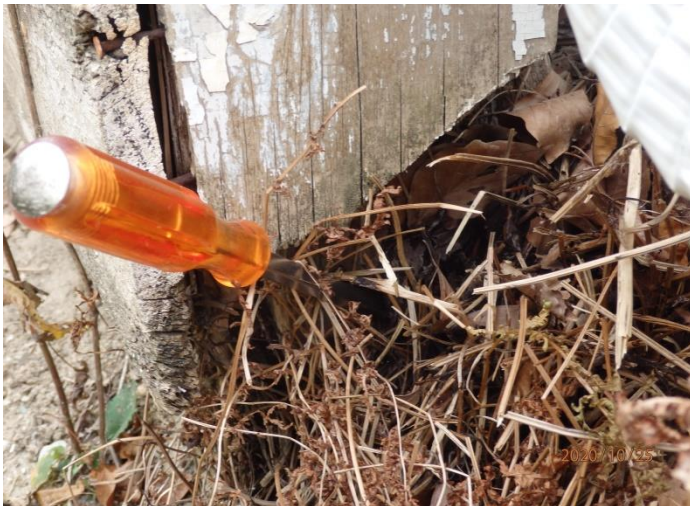
Support column at left rear porch was rotted

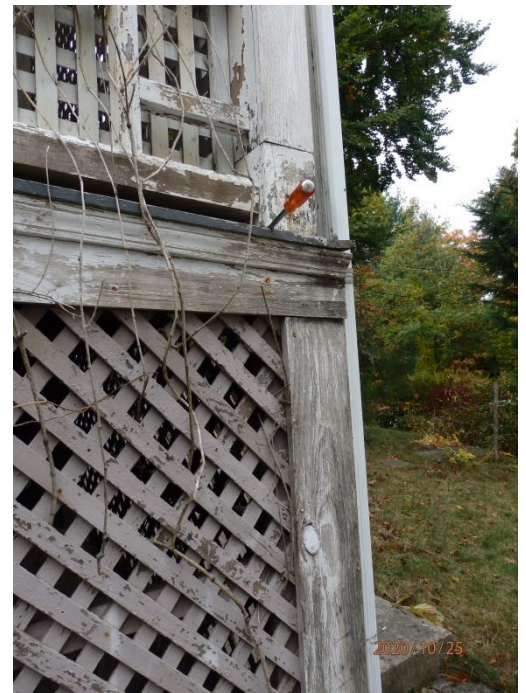
Corner support was rotted / loose at left rear porch.

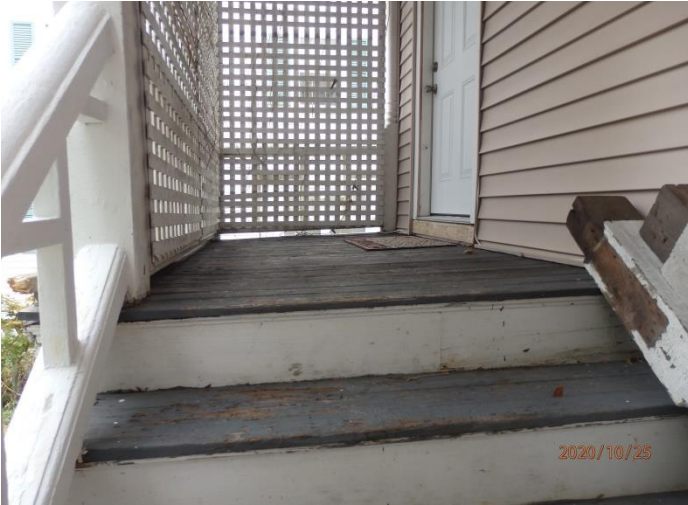
Left rear porch was sloped / pitched down away from house.

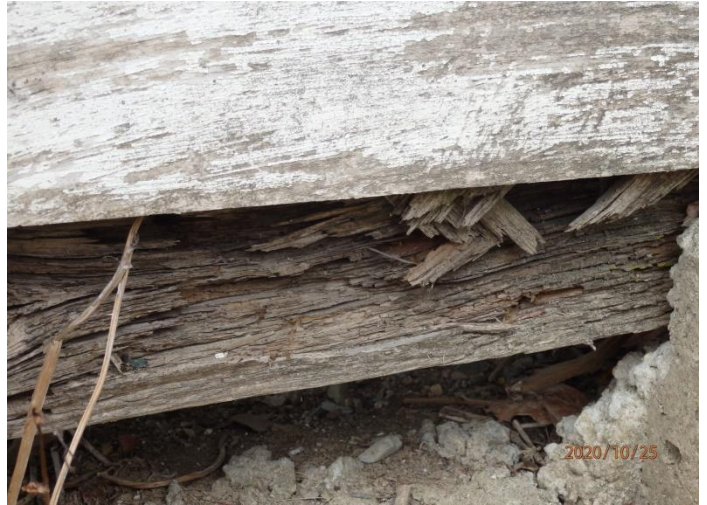
Rotted wood at left rear porch

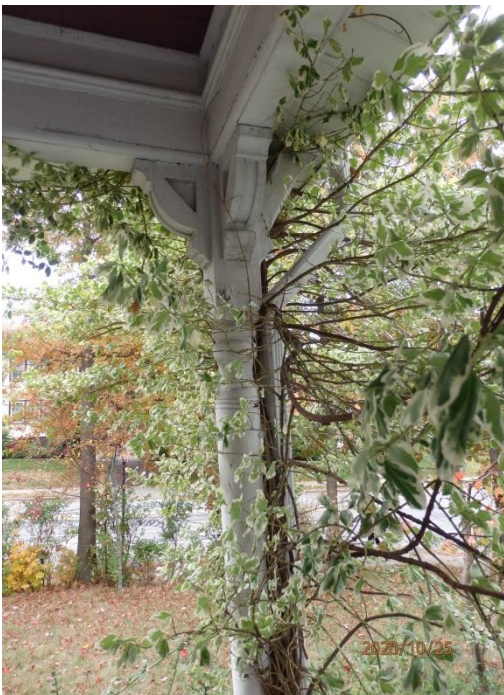
Recommend removing the shrub growing around the front porch corner support

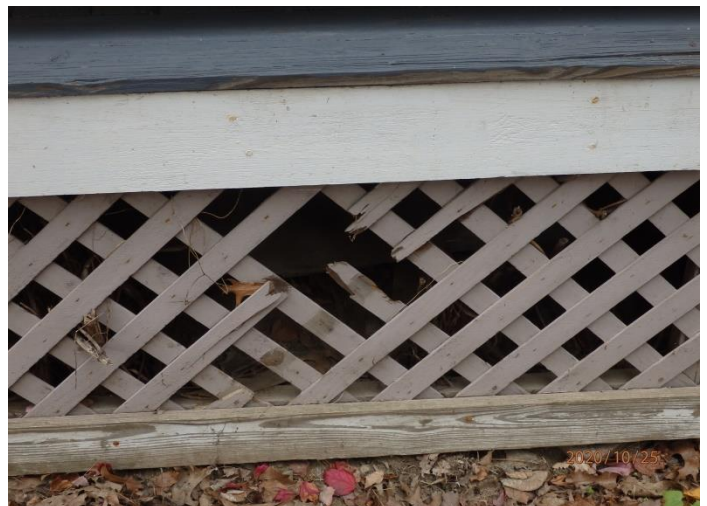
A few broken / missing lattice trim sections were found at the front porch

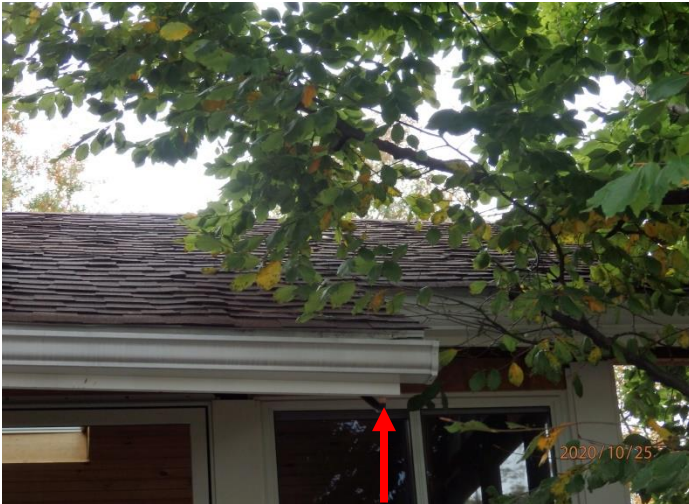
Investigate Further - The roof overhang at the entrance area next to the newer sunroom porch did not have a corner support. Recommend checking with owner to determine if a building permit was obtained for the sunroom porch / carport roof.

Vertical support might be needed here

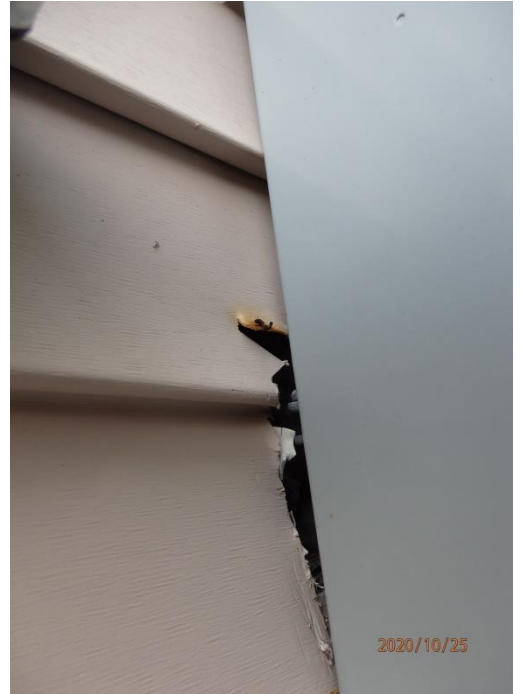
This opening behind the exterior electric meters needs to be properly sealed up.

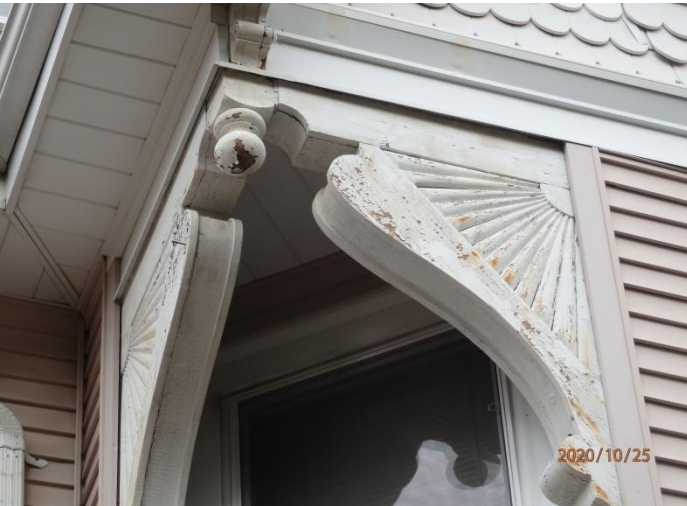
Most of the house wood trim is in need of scraping and re-painting (be aware that lead paint is likely present.)

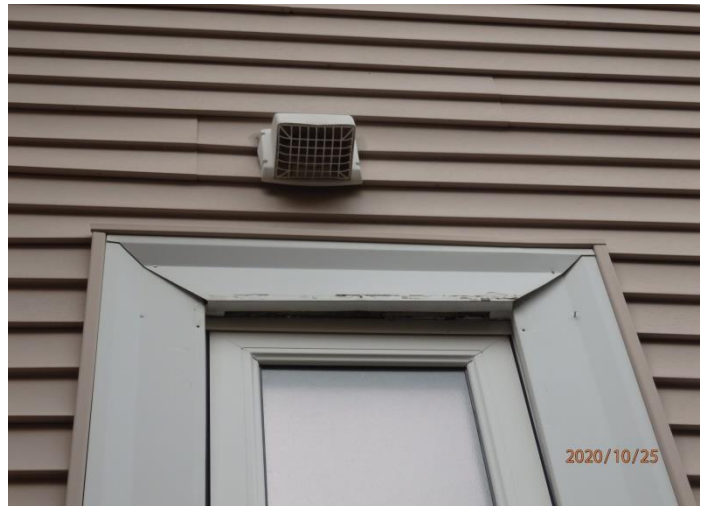
Aluminum trim was loose at a couple of right side windows, repair needed.

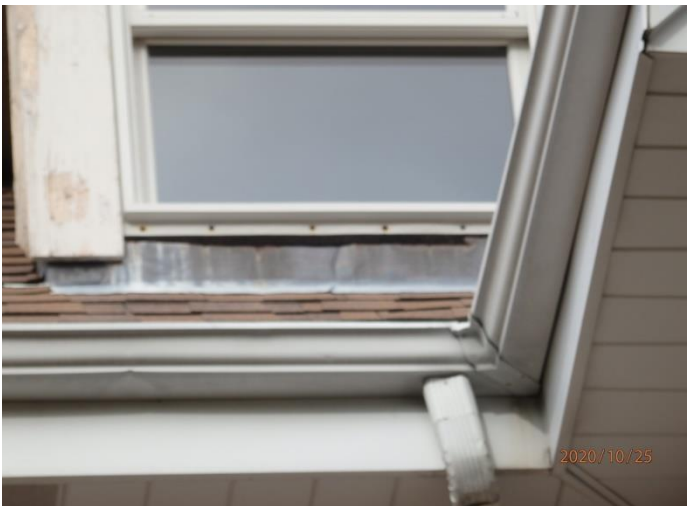
Finishing work / trim needed at right side dormer window.

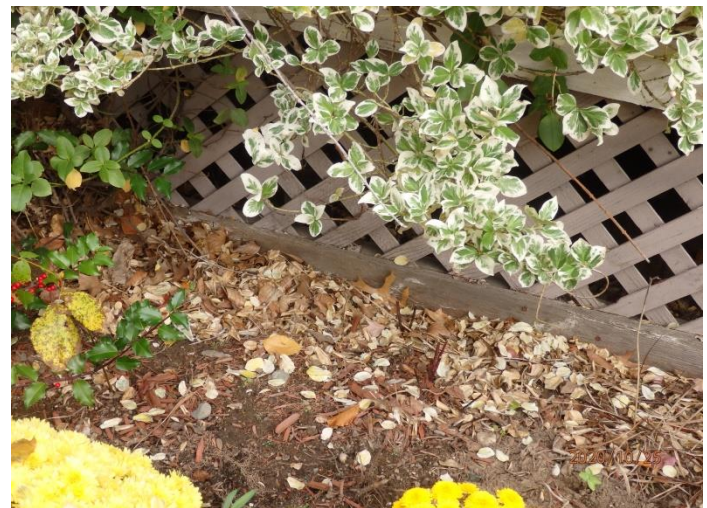
Front porch trim in ground contact is subject to rot and insect damage.

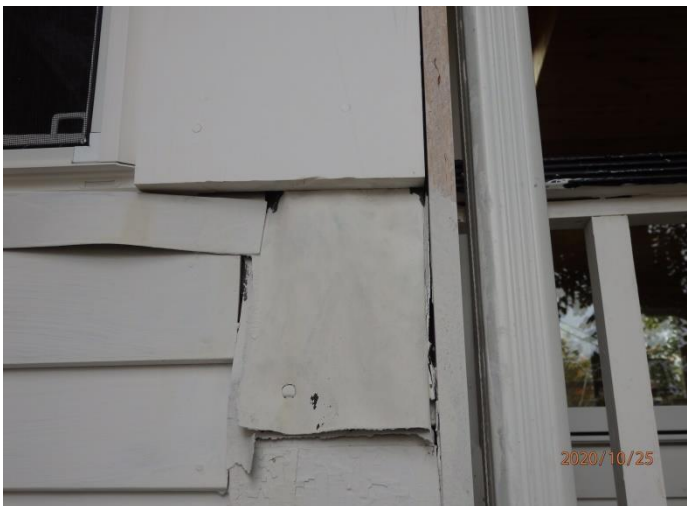
Proper siding covering was lacking next to stairway at new sun porch.

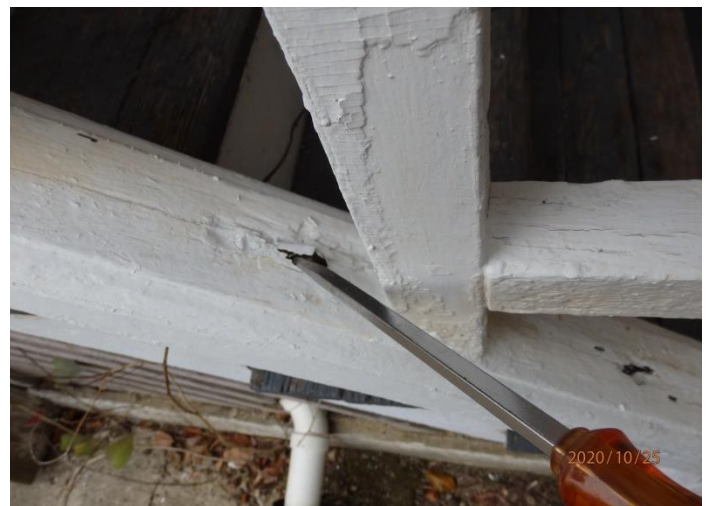
Rotted railing section at left rear porch

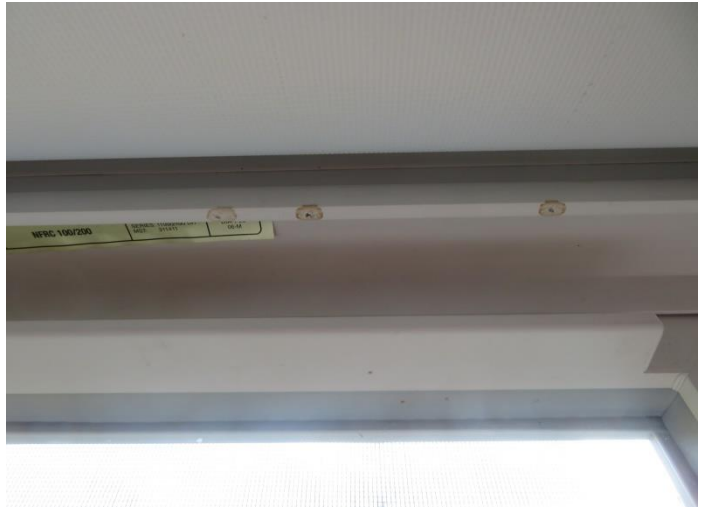
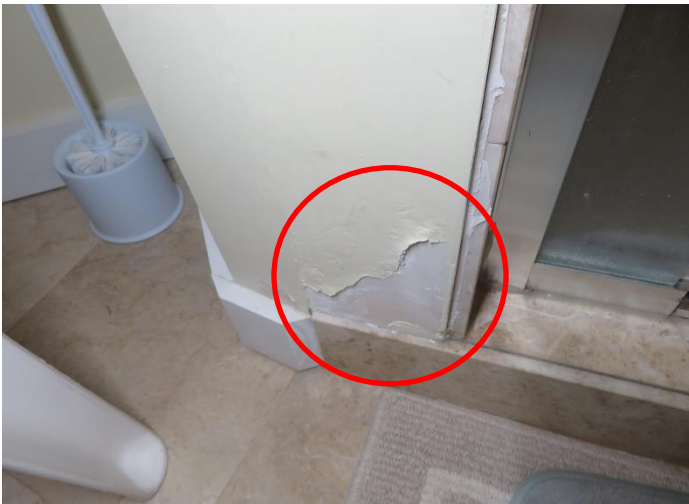
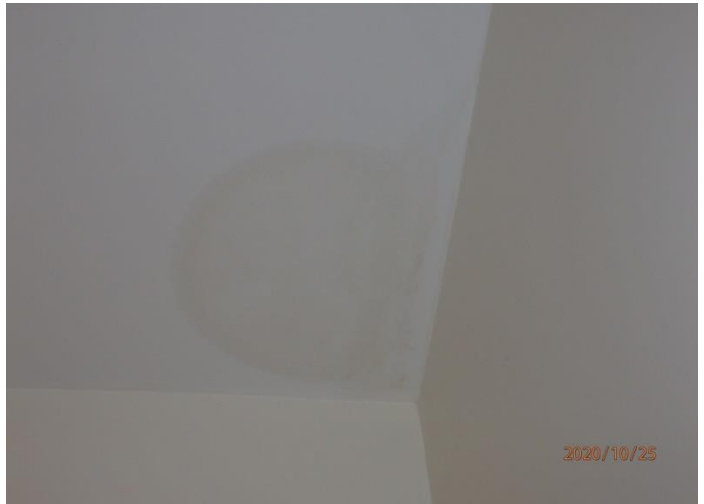
Water damage found at 3rd floor master bath wall.

2nd floor pantry ceiling, this appeared to be the area between the rear sloped roof and the rear vertical wall.

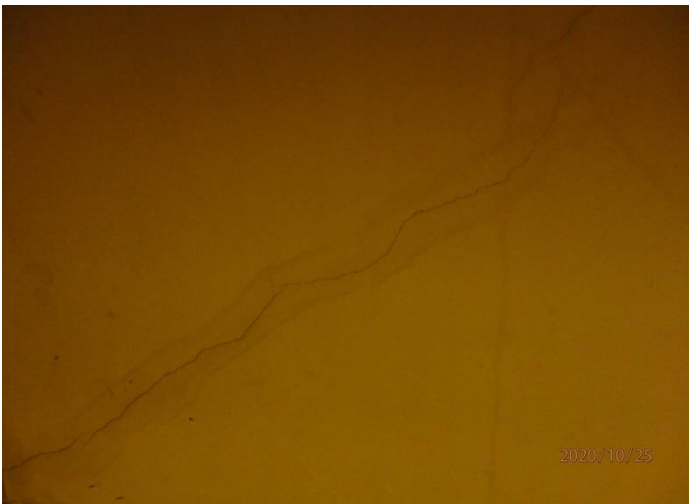
Wall crack with a water stain found at a rear 3rd floor stairway hall closet

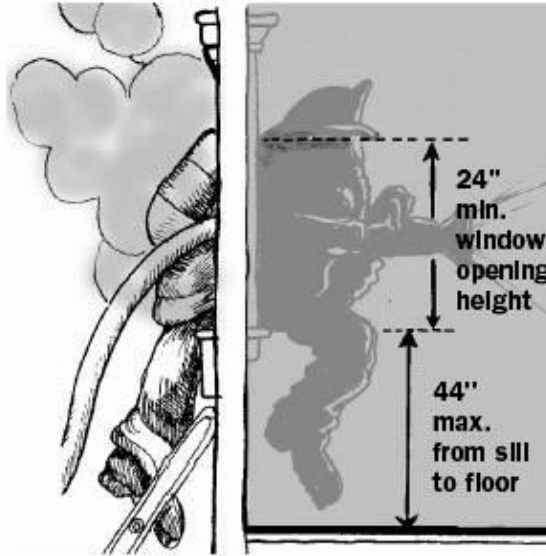
Fig. b13
Bedroom Window Egress

All sleeping rooms should have at least one means of emergency egress, either a door leading to grade level or one openable window with a sill height no higher than 44" from the floor that has an opening size of at least 24" high by 20" wide. This safety standard was not in effect for homes built before around 1975. The dimensions of the opening are to ensure the occupants an escape route, but equally important, they are designed to allow a firefighter with a backpack to enter. The installation of at least one window in every bedroom (sleeping room) that meets the existing safety standards for emergency egress should be considered. (3rd floor windows opened up under 18 inches high.)

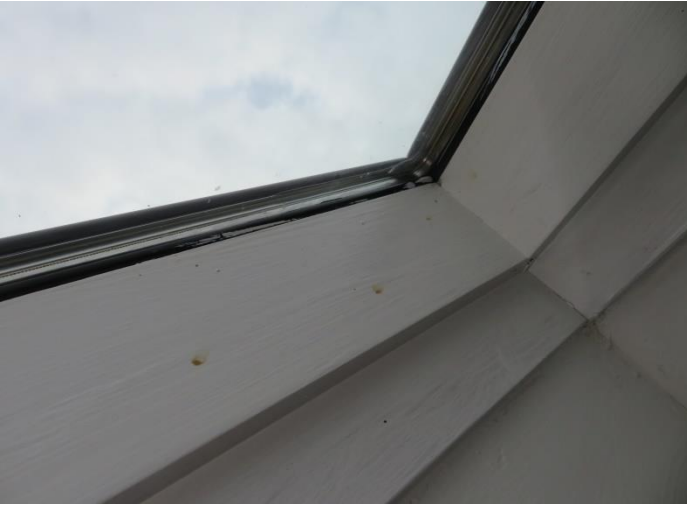
A few water spots / stains were found under a skywindow

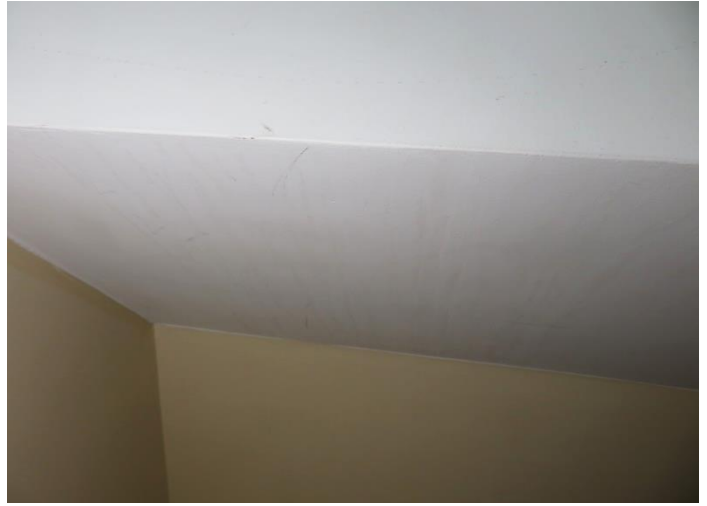
Faint stain streaks were found under another skywindow

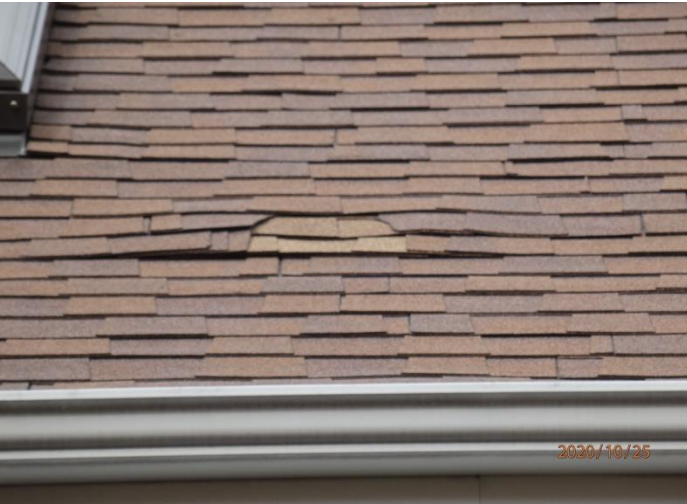
There was a damaged shingle section on the right side of the roof. Check further with owner. Repair needed.

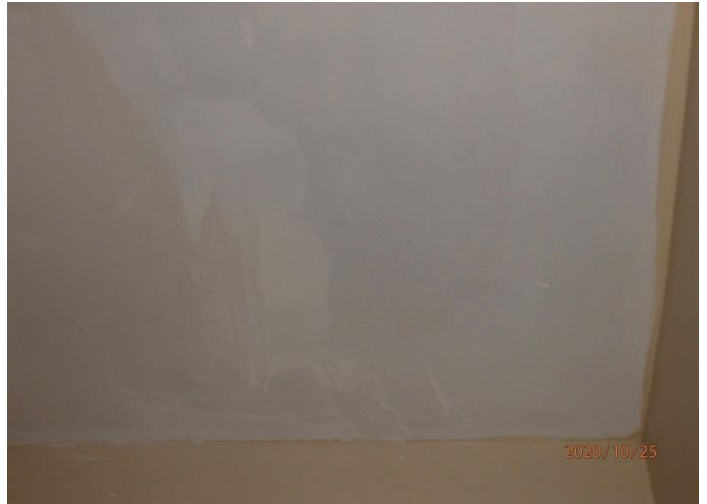
Water stain found at 3rd floor closet ceiling

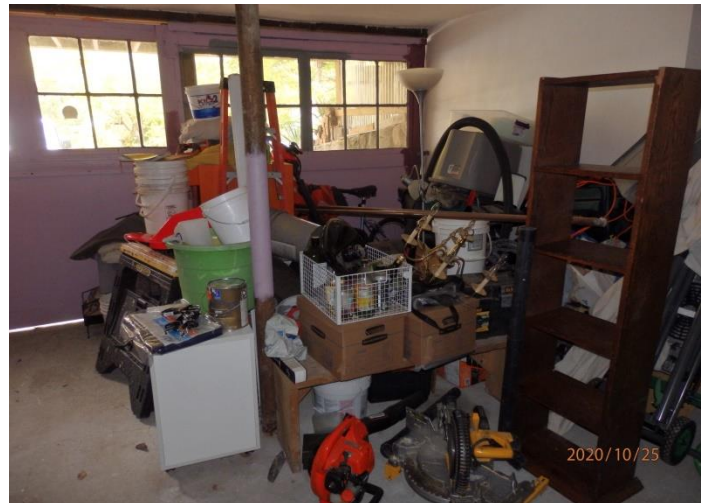
Stored items in garage limited observations.
